# NASA Technical Memorandum 58244

## Full-Scale Flammability Test Data for Validation of Aircraft Fire Mathematical Models

Jerome F. Kuminecz and Richard W. Bricker  
*Lyndon B. Johnson Space Center  
Houston, Texas*

February 1982

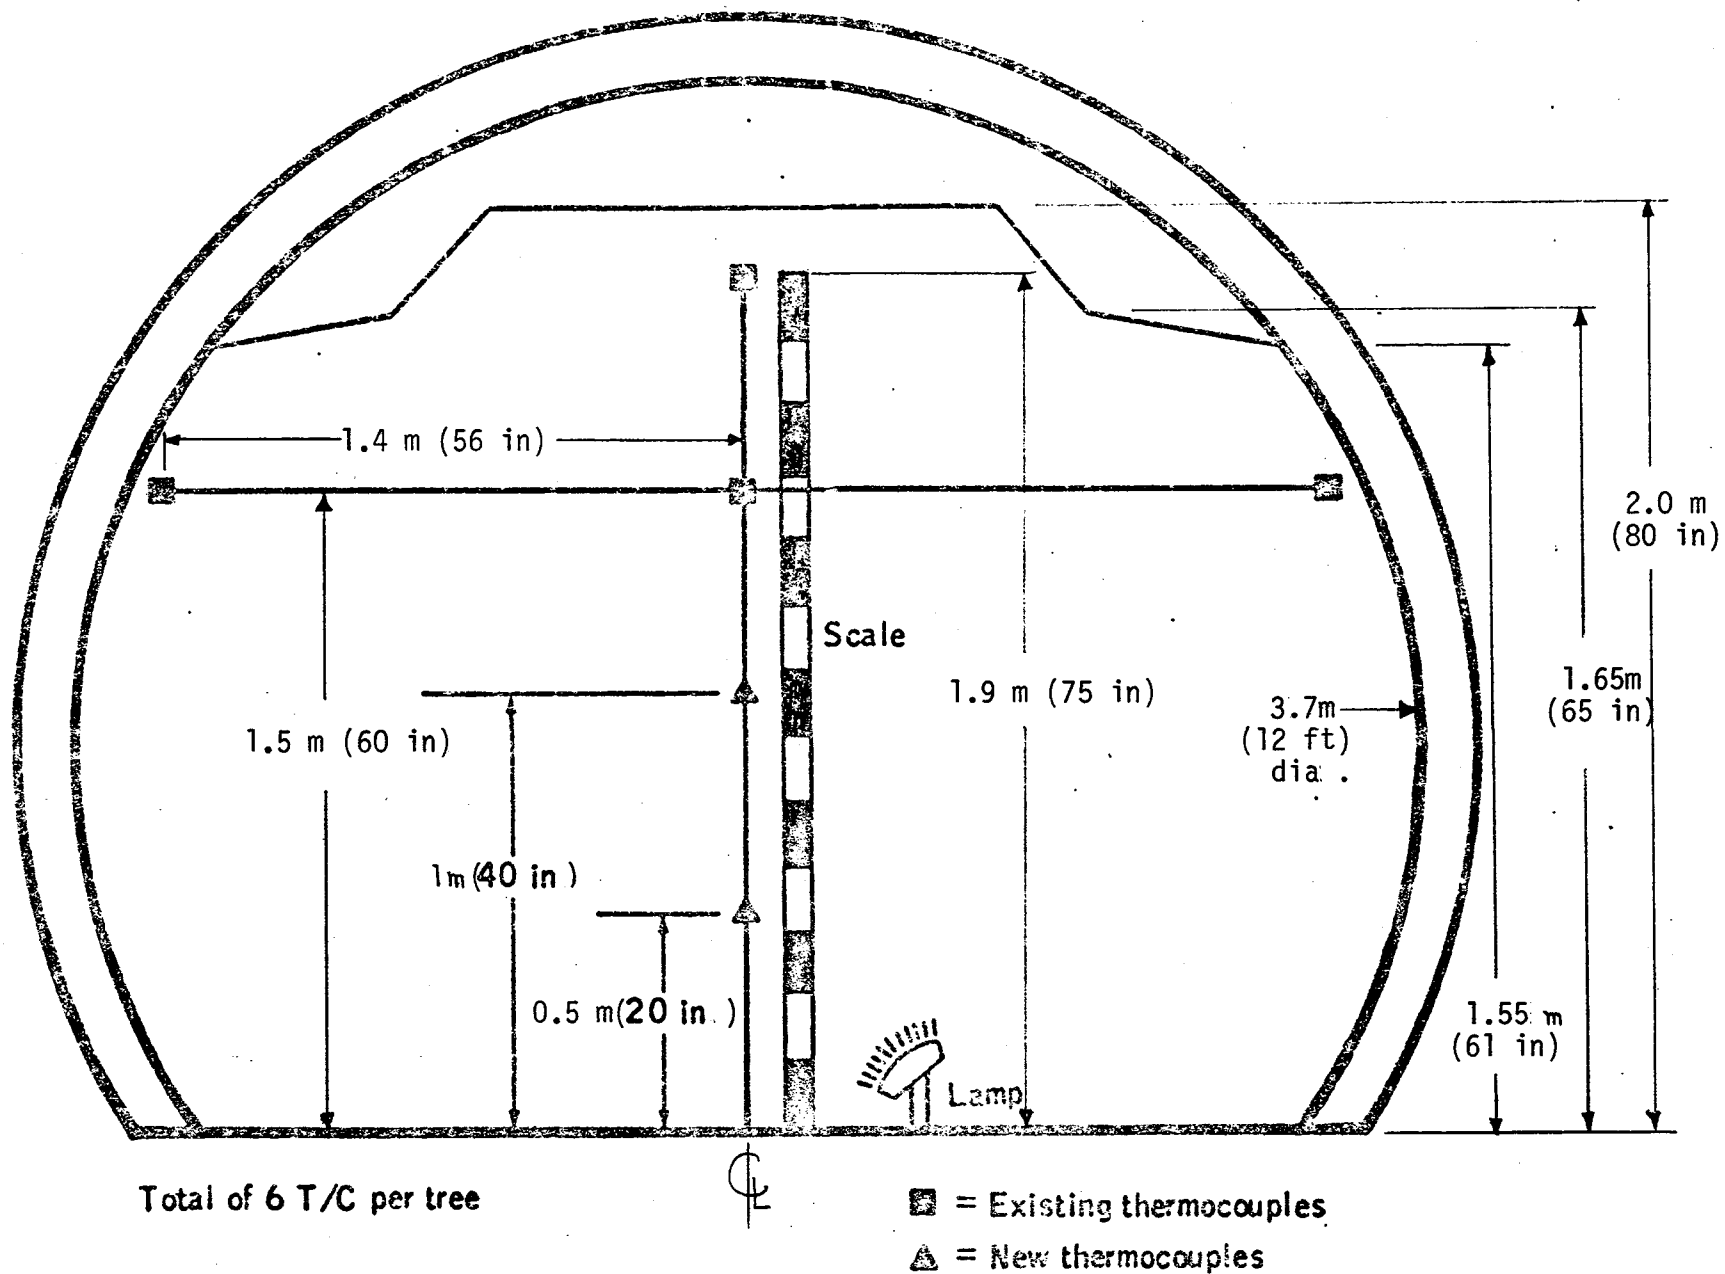
Figure 17. - Thermocouple Tree T/C Locations (and Overhead Panel Heights)

Chromel-alumel thermocouples were used to measure free-air and material temperatures. They were installed at over 130 locations (figs. 2, 7 to 9, 11, 12, and 17 to 21). Thermocouples which were installed on cabin materials were referred to by the designation "T/M".

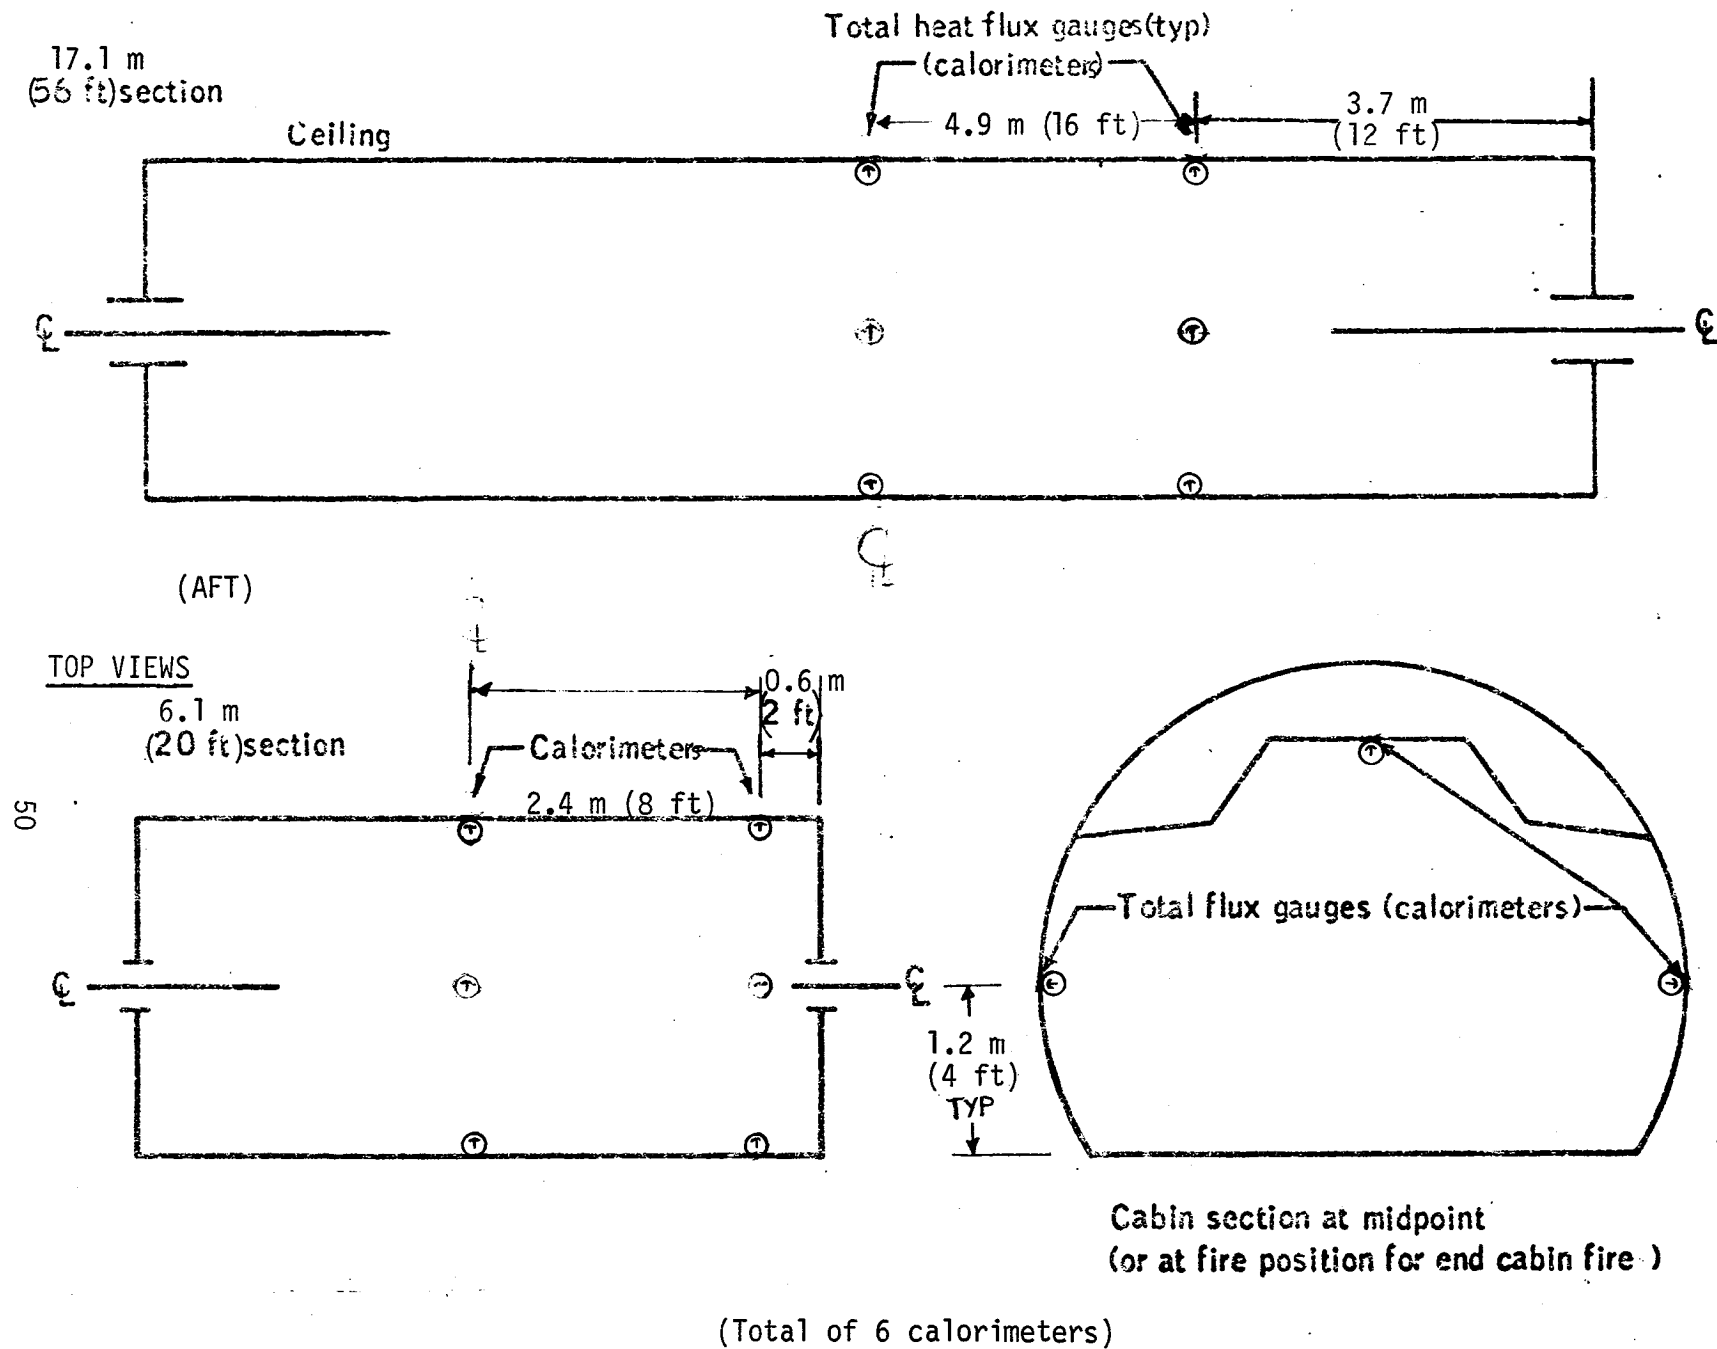
Figure 22. - Calorimeter Locations

Six water-cooled calorimeters were installed, as shown in figures 2 and 22, to determine the heat flux generated by the fire. Three were located on the midline of the fuselage, around the fire, while the remaining three were located near the aft end of the fuselage.

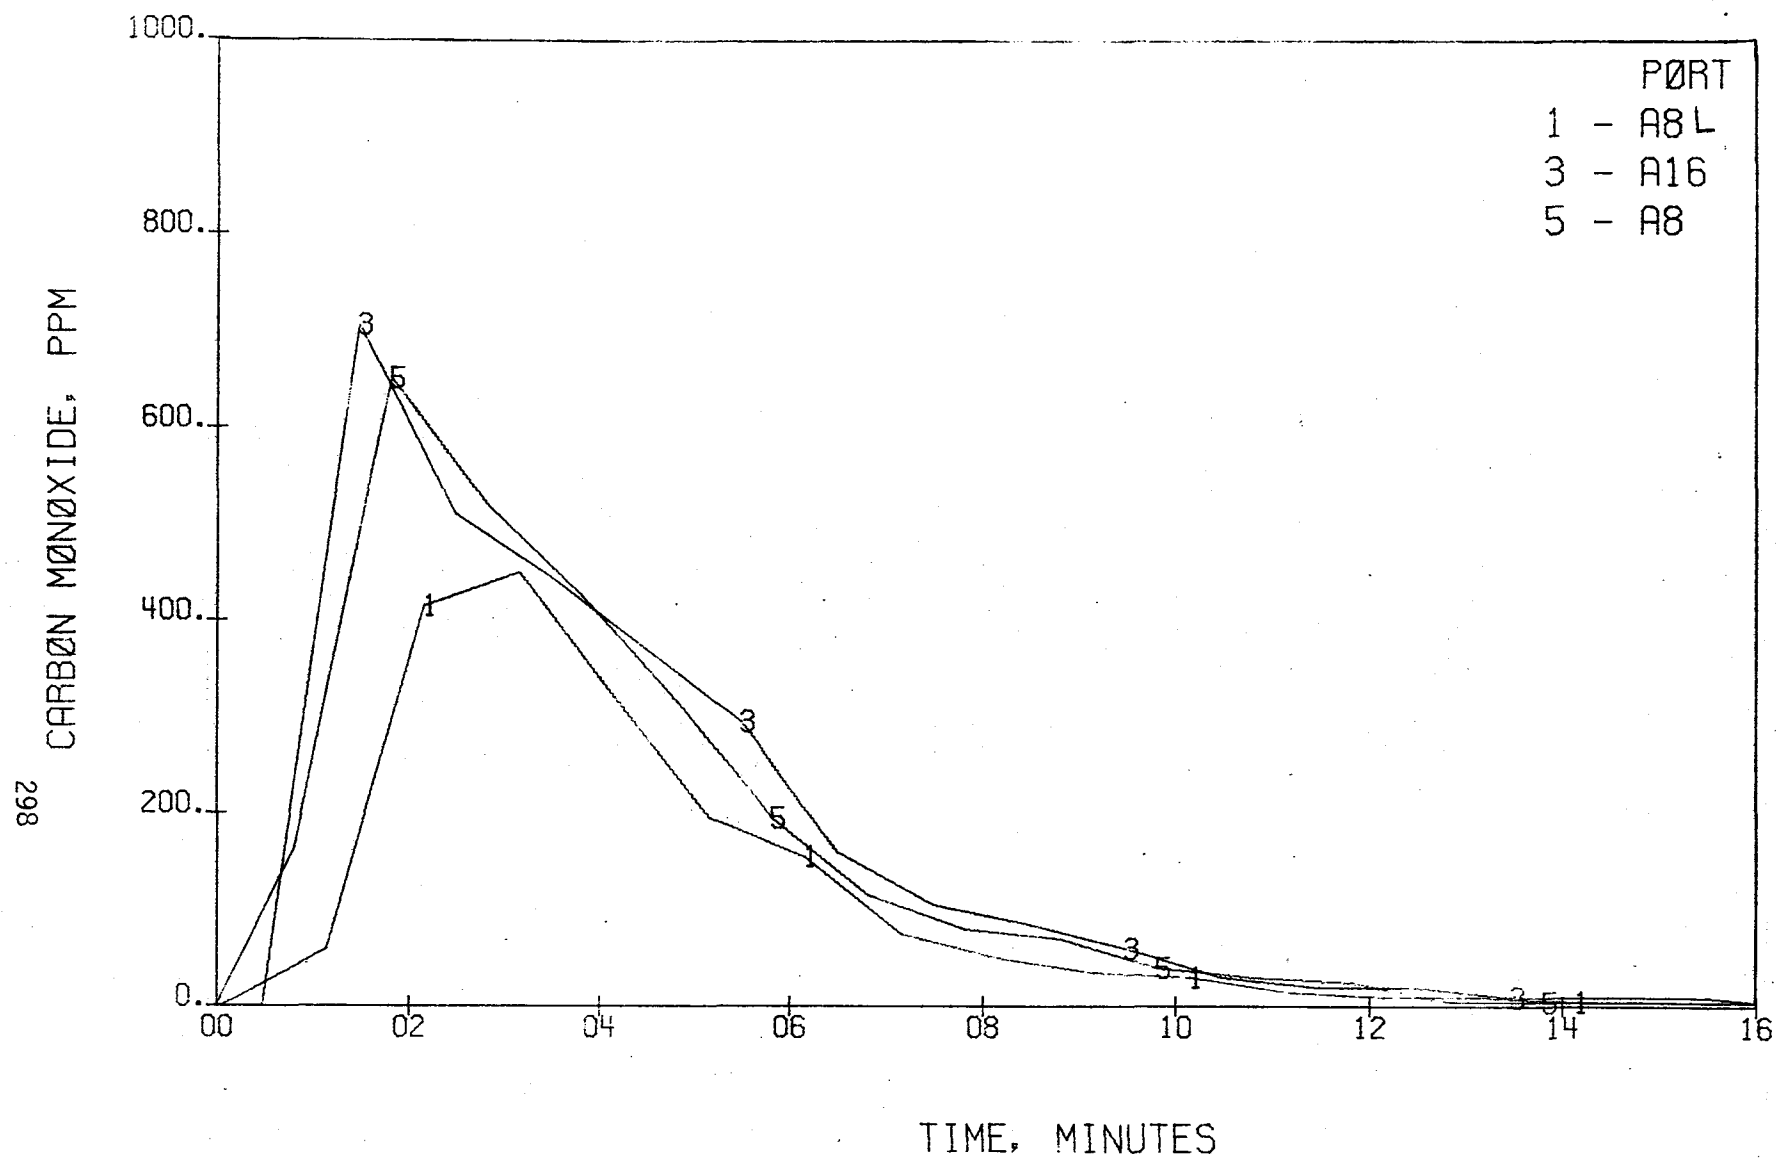
FIGURE 214 - CARBON MONOXIDE CONCENTRATIONS, AFT  
TEST 13

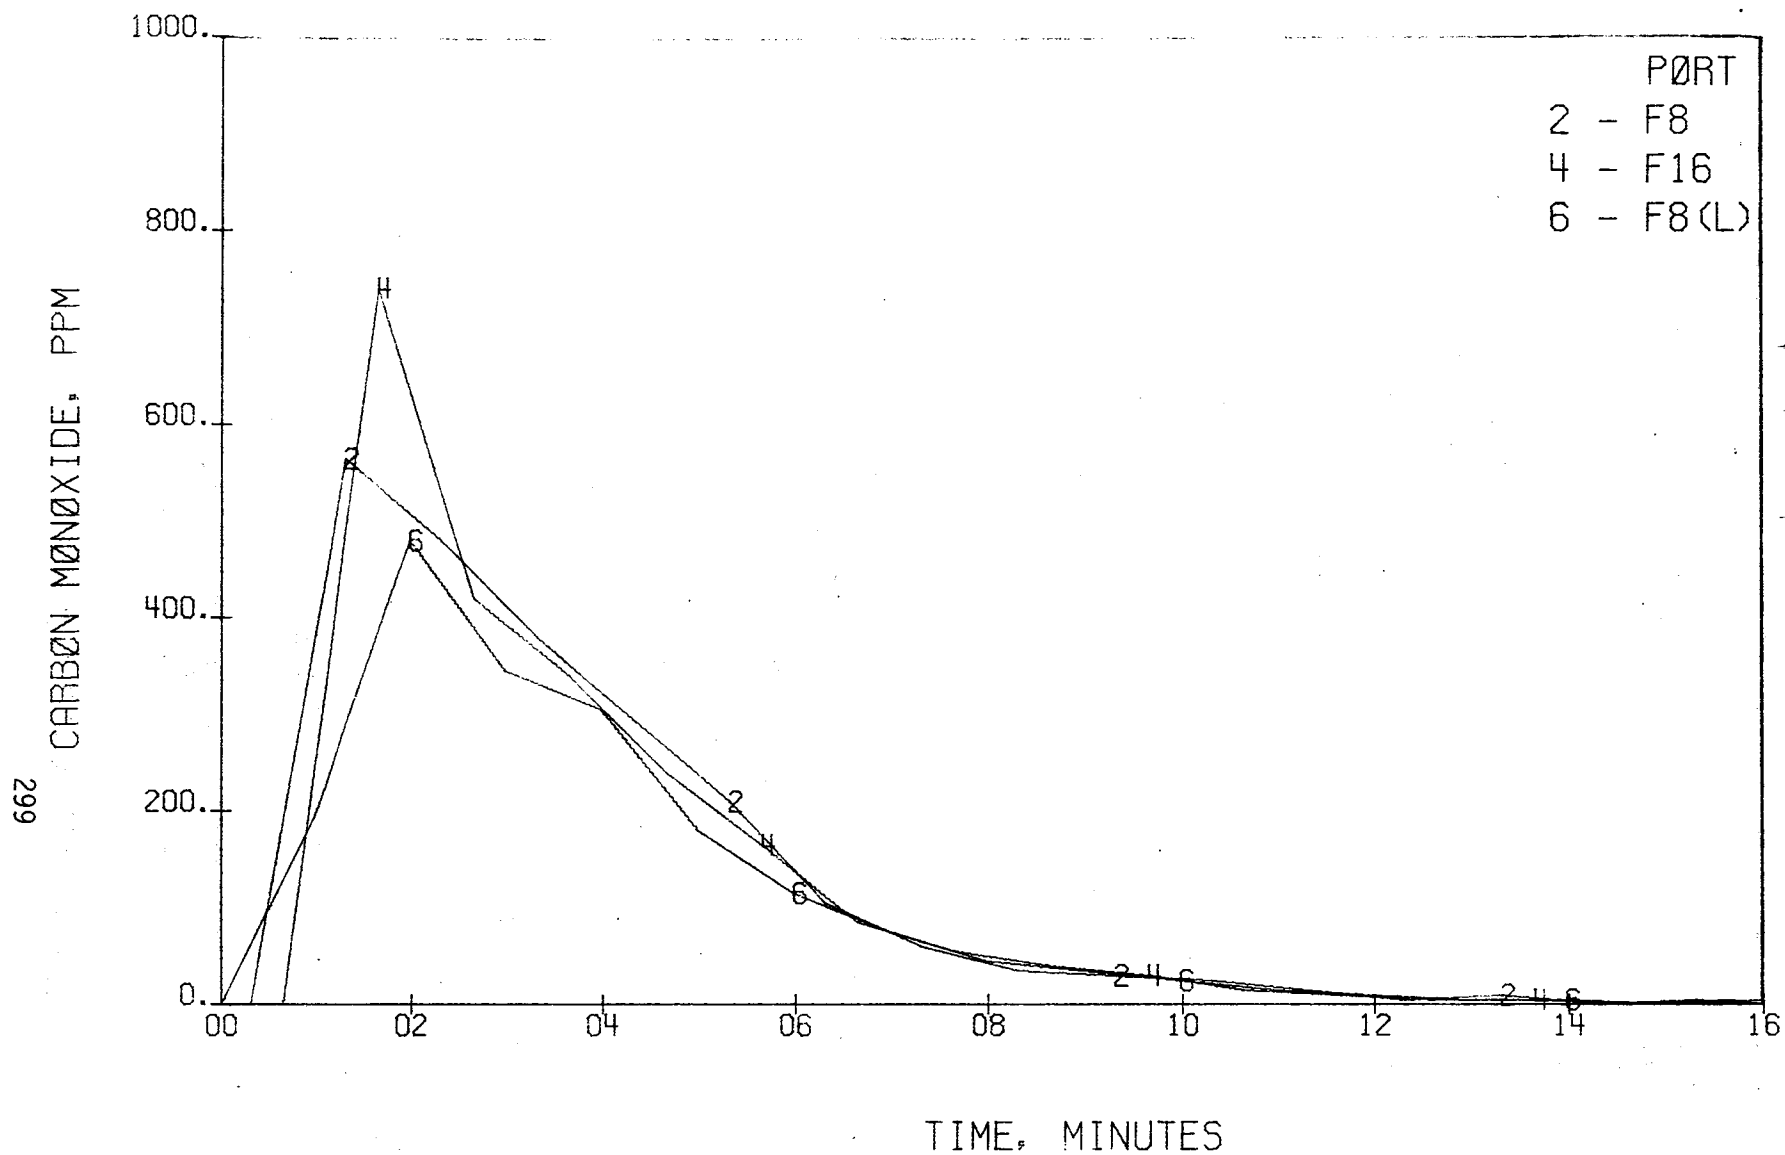
FIGURE 215 - CARBON MONOXIDE CONCENTRATIONS, FØRE  
TEST 13

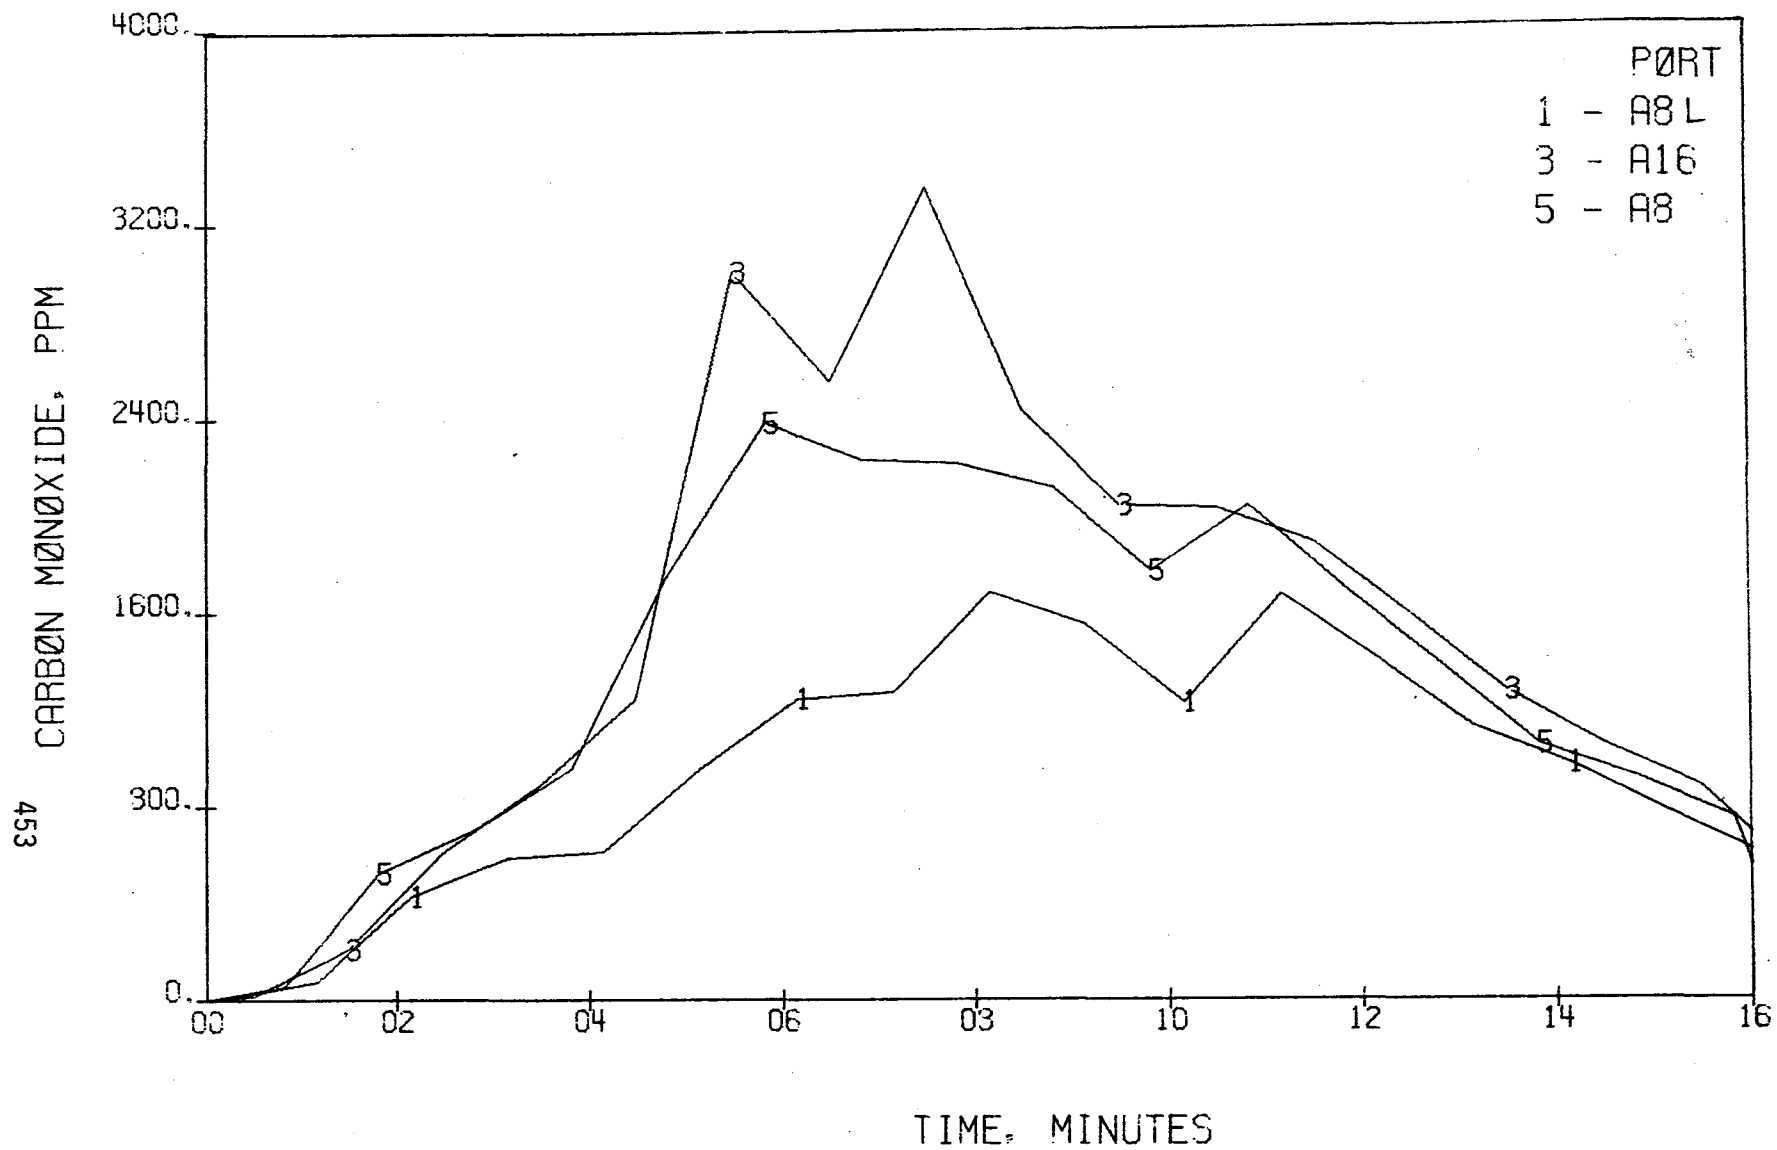
FIGURE 345 . - CARBON MONOXIDE CONCENTRATIONS, AFT  
TEST 17

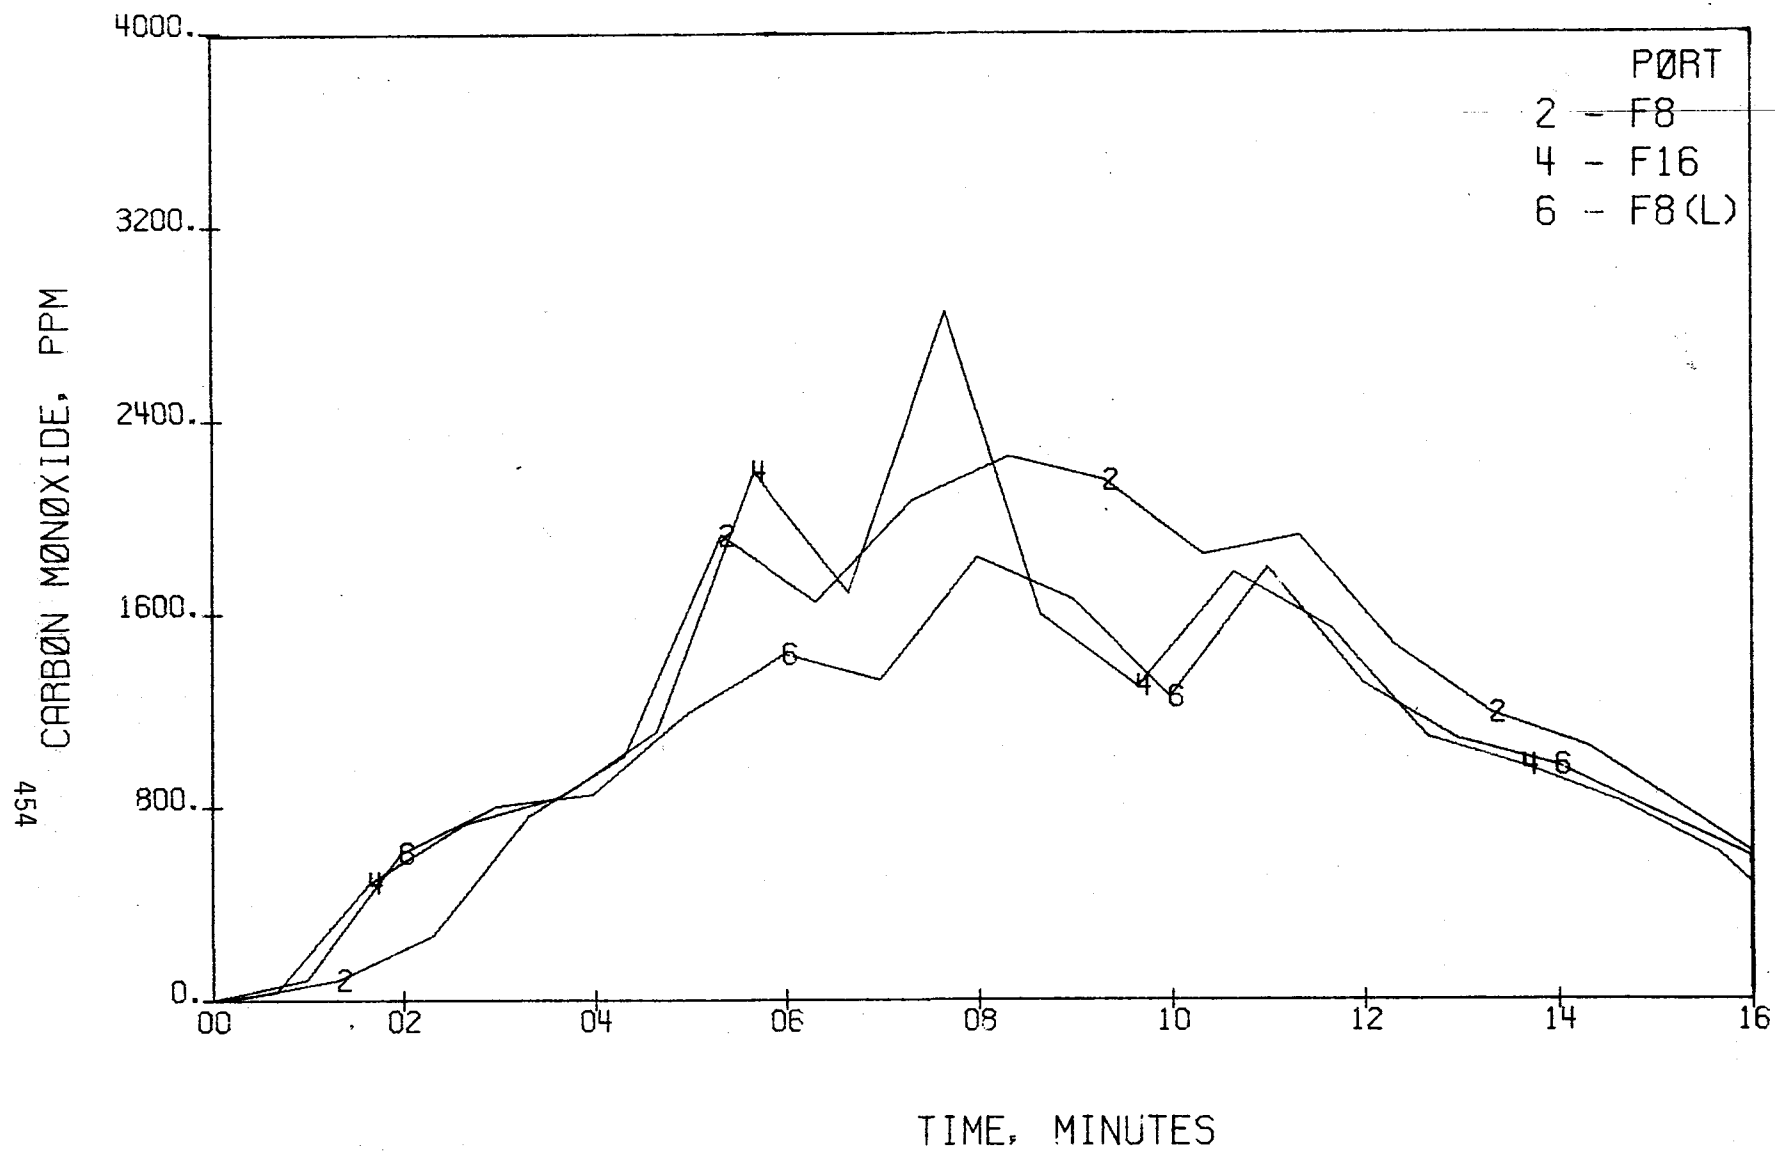
FIGURE 346 . - CARBON MONOXIDE CONCENTRATIONS, FØRE  
TEST 17

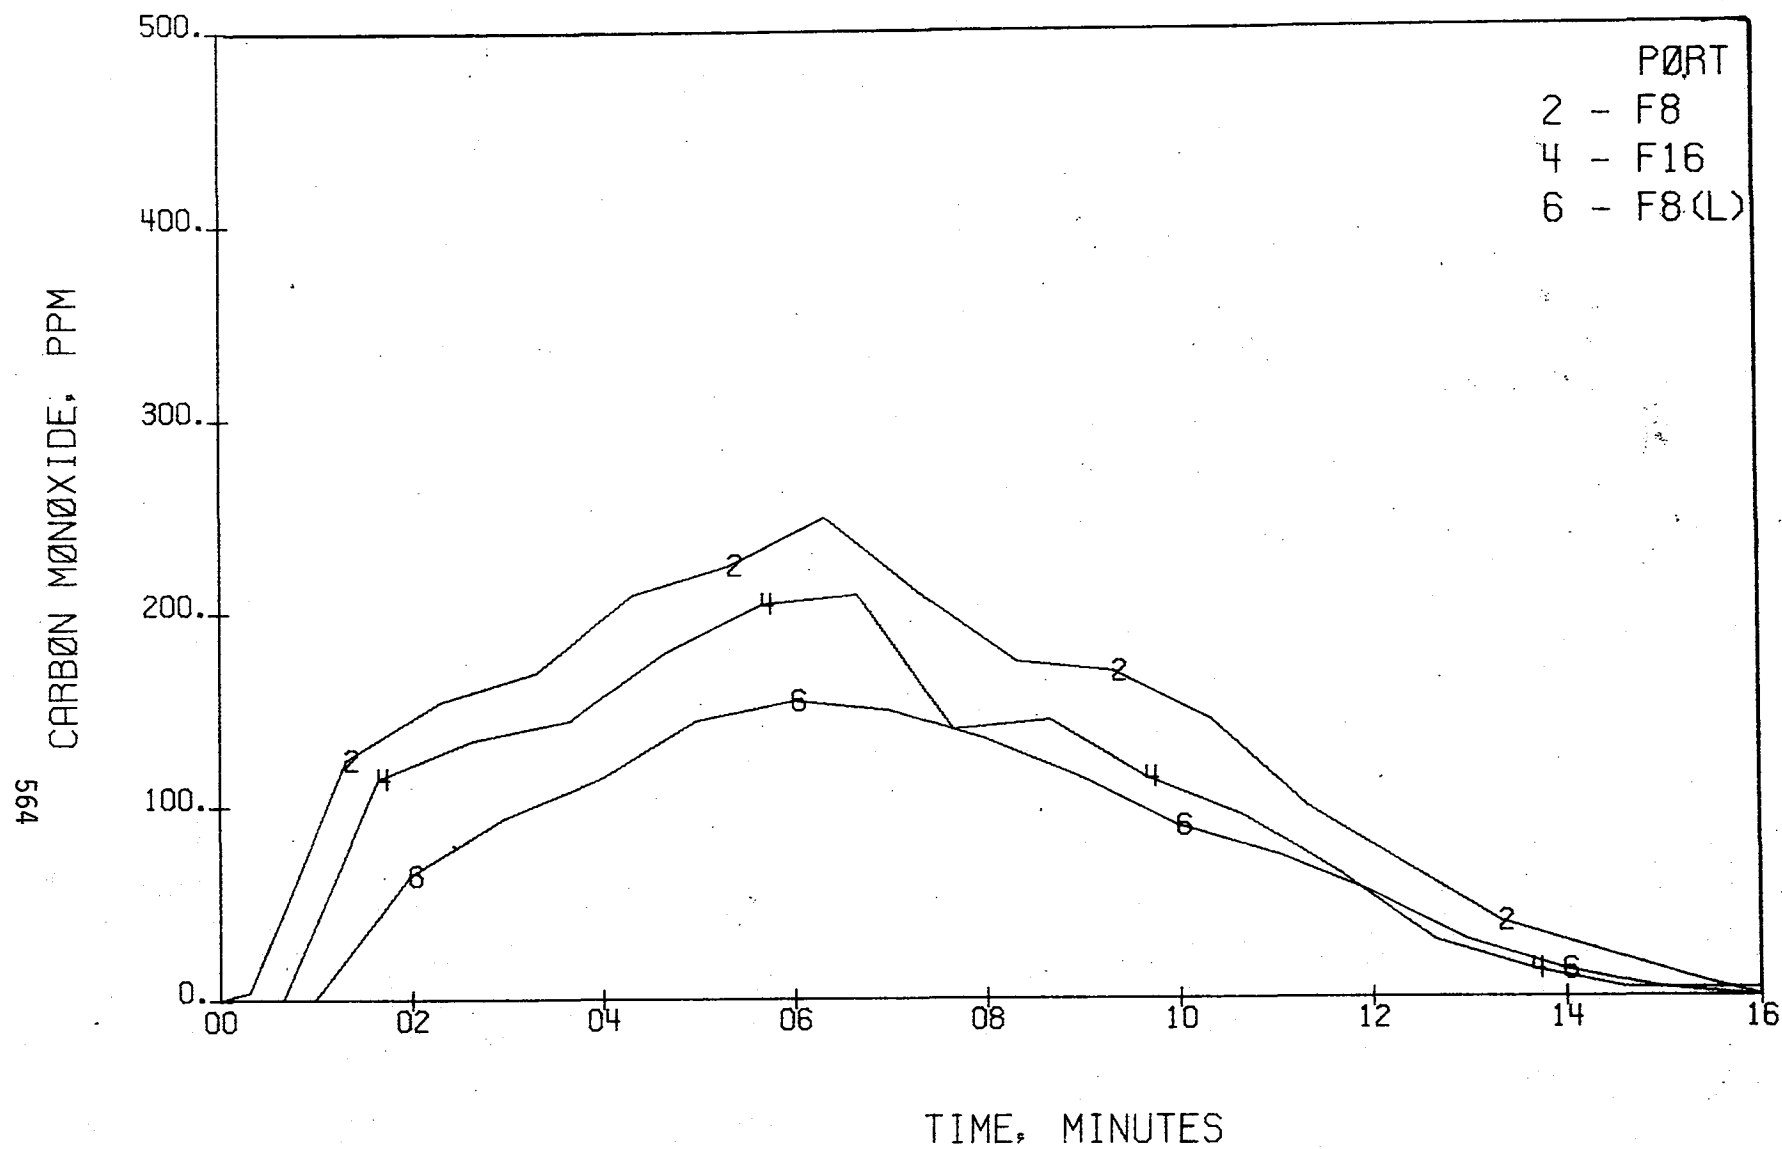
FIGURE 444 - CARBON MONOXIDE CONCENTRATIONS, FØRE TEST 20

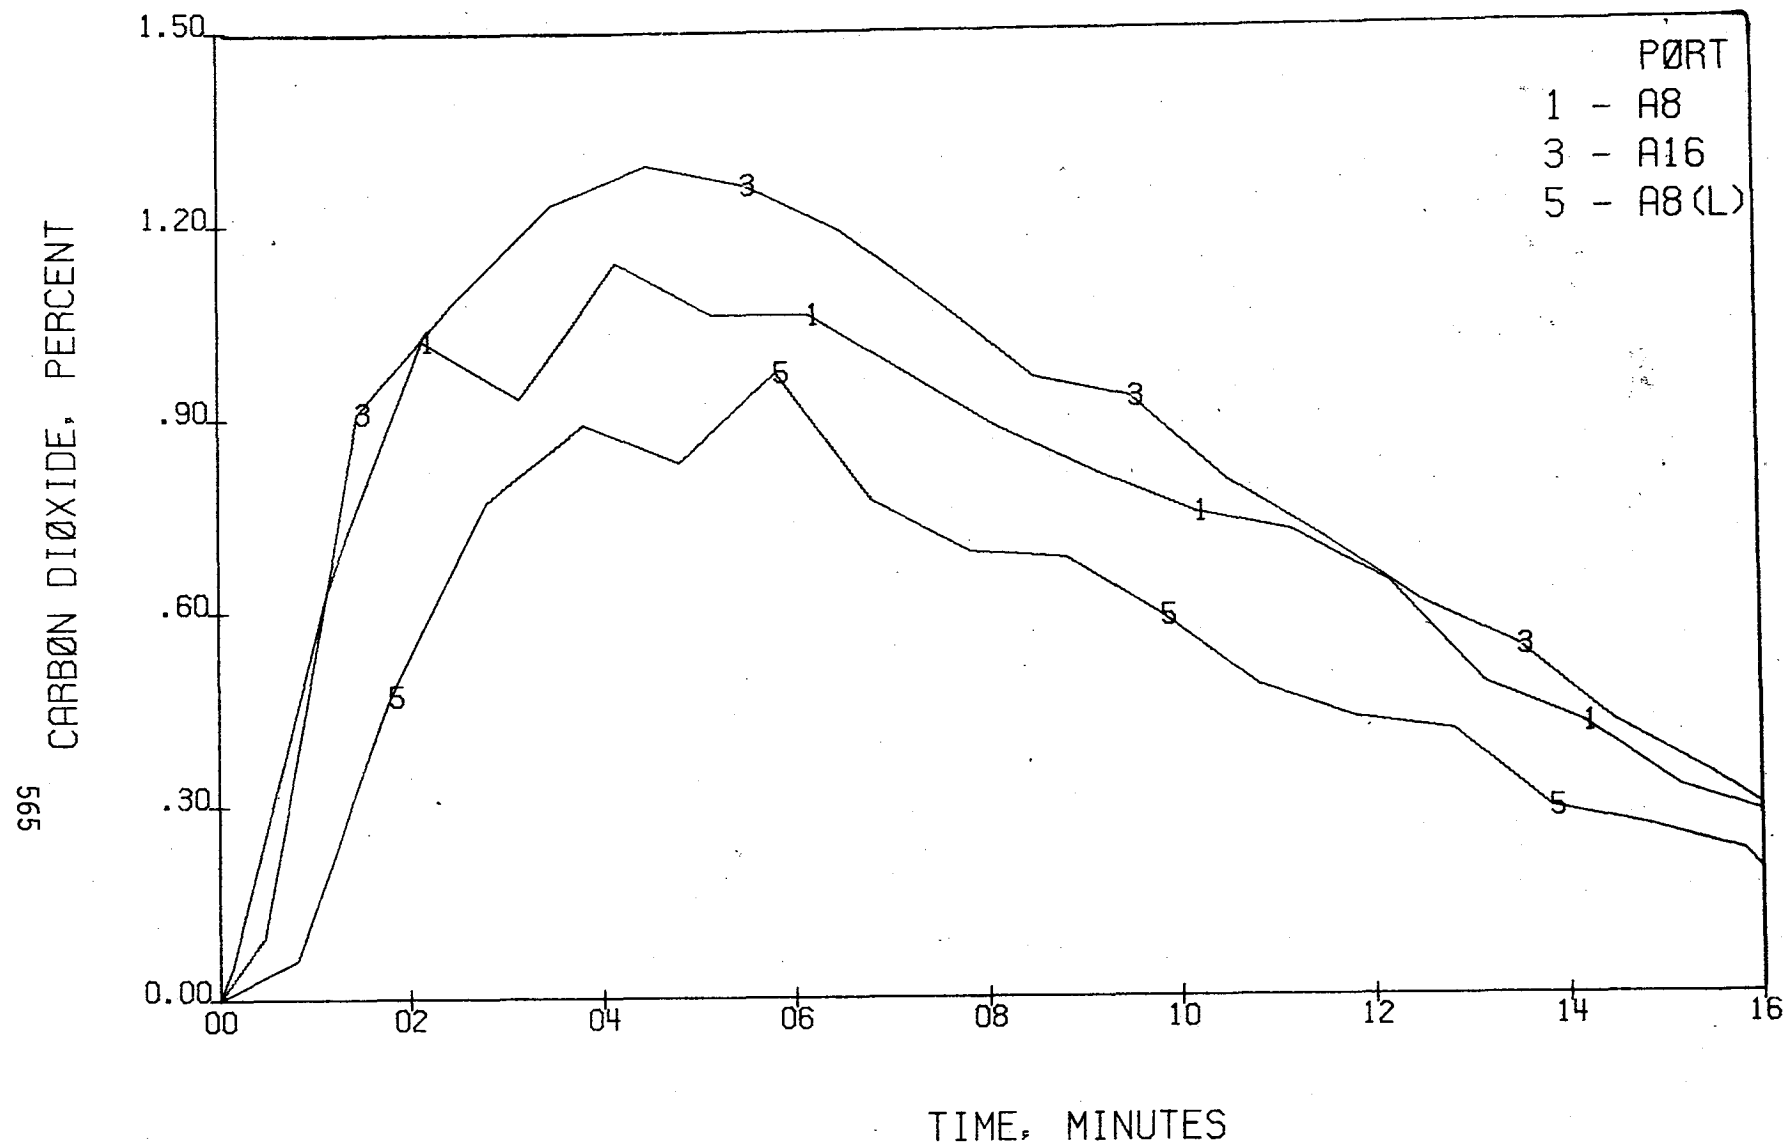
FIGURE 445 . - CARBON DIOXIDE CONCENTRATIONS, AFT  
TEST 20

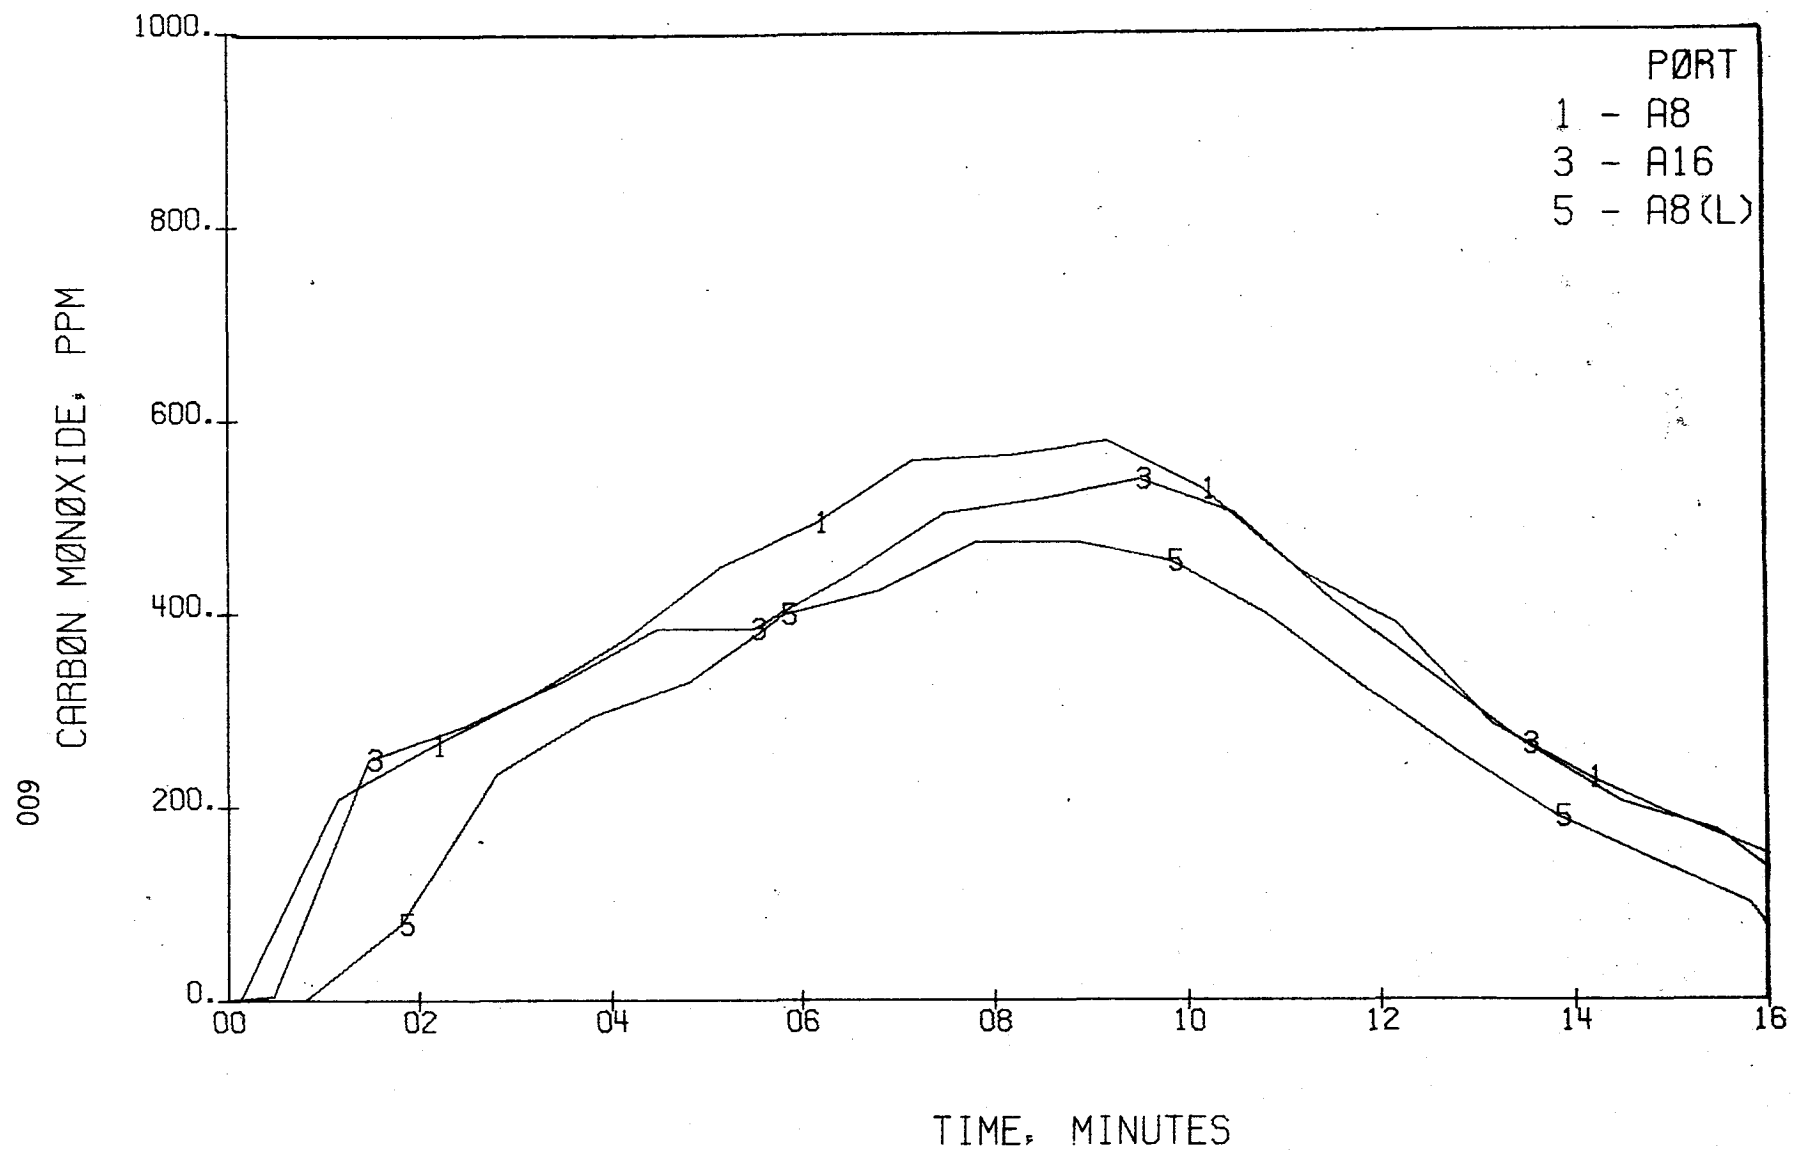
FIGURE 476 . - CARBON MONOXIDE CONCENTRATIONS, AFT  
TEST 21

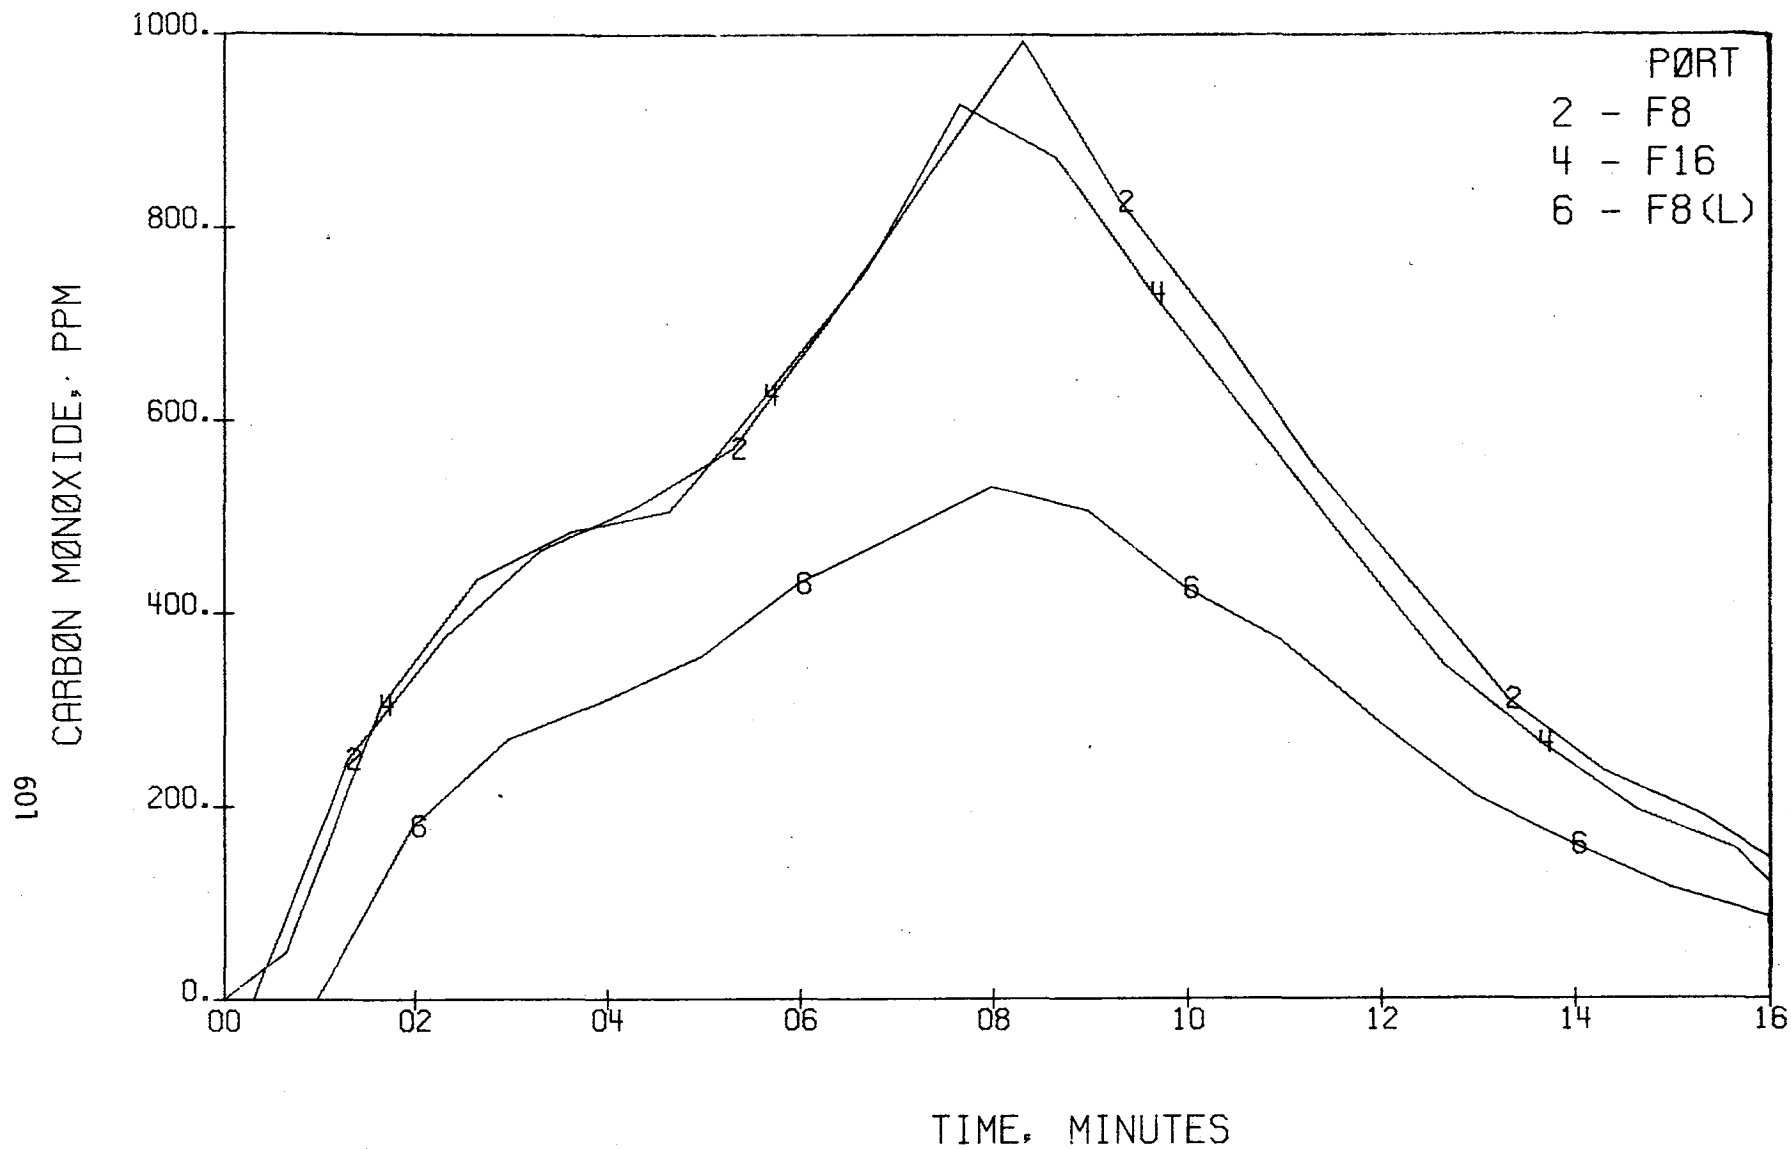
FIGURE 477 . - CARBON MONOXIDE CONCENTRATIONS , FØRE  
TEST 21

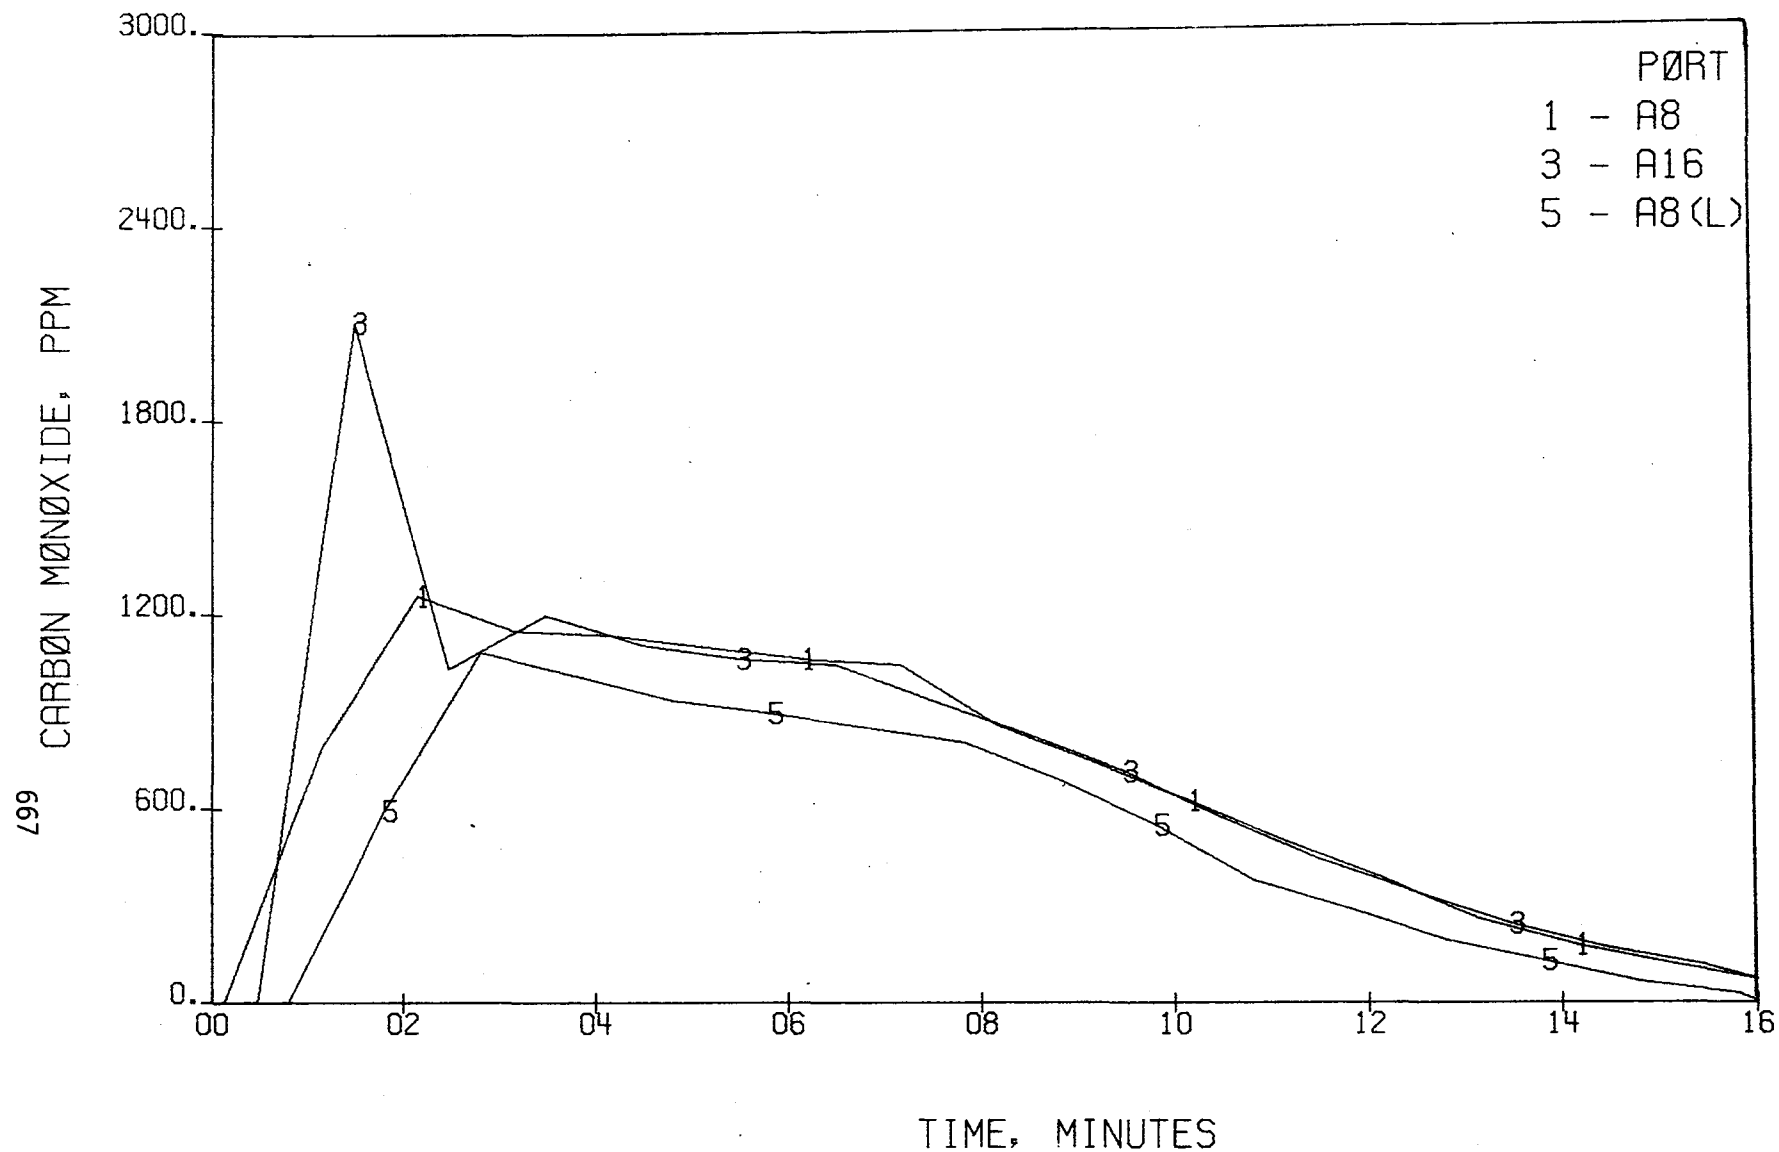
FIGURE 534. - CARBON MONOXIDE CONCENTRATIONS, AFT  
TEST 23
